Service history of an IC-706 MkII G

Jonathan Hare G1EXG is determined to keep his IC-706 working (and succeeds).

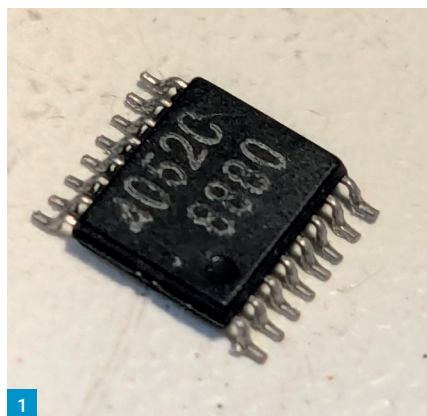
Fig. 1: The loose chip.

I contacted Icom and they kindly sorted out a set of leads which I ordered. On opening up the radio, I dropped a small screw inside so I tipped the radio upside down to get it out and to my amazement a tiny 16-pin surface mount device (SMD) chip (4052C integrated circuit) fell out as well (see photo, Fig. 1)!

At first, I thought it must have got in there by accident while it had been serviced, but on looking around one of the boards I soon found where it had come from. These chips are very light (ca. 100mg each) and even if one pin is soldered on to the PCB it would be hard to dislodge it simply by shaking or knocking the radio. With 16 pins to secure the device it is extremely unlikely it would come off. Even if you dropped the radio off a ten-storey building, I doubt the impact would dislodge an SMD chip (although it would of course do a lot of other damage!).

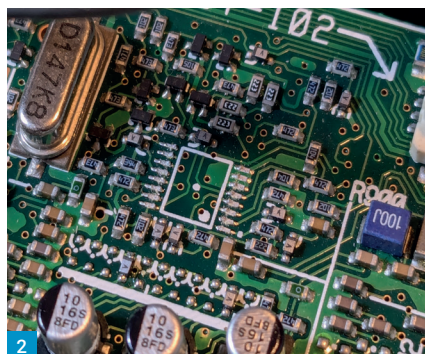
Fig. 2: The circuit board with an empty space!

How on earth did an SMD chip fall off a PCB? Your guess is as good as mine, but if you look at the photos, Figs 2 and 3, you can see that the solder left on the PCB is rather fragmented. Perhaps the SMD solder paste used was rather old and it simply fragmented over time.

A scientist colleague suggested an interesting, but probably unlikely possibility, that this story might be a case of 'tin pest' [4]. This is when changes in the crystal structure of tin-based products at low temperatures cause these products to fragment [4]. With the 2006 RoHS changes in the use of lead in solder the problems of tin-pest have returned. You can see, Figs 4 and 5, that I keep my radio on my backpack in a waterproof storage crate. Thinking it was safe from moisture, I had kept all the gear in my garage over winter and it would probably have been cold for weeks at a time. I am not sure if it was cold enough to produce this effect though. And if the chip did

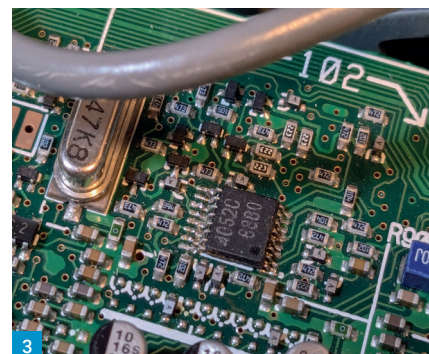
Fig. 3: The chip back in place.

Would the radio work if I put the chip back? Before I tried, I went over the solder paste with a small tip soldering iron to produce a good contact for the chip pins. I noticed that there was always a white marker on the PCB corresponding to the indentation on the chip (you can just about make it out on the photo). Following this layout, I orientated the rogue chip and carefully soldered it back onto the PCB as best as I could. To my amazement on powering up, the radio worked! A few days later, I returned to my portable hill site with my repaired IC-706 and even in fairly poor conditions, worked into Russia, Ukraine and China on the 10m band.
